SPRU Disposition Project

Cheryl Cabbil
URS Global Management & Operations Services

March 17, 2011

SPRU Disposition Project Path Forward

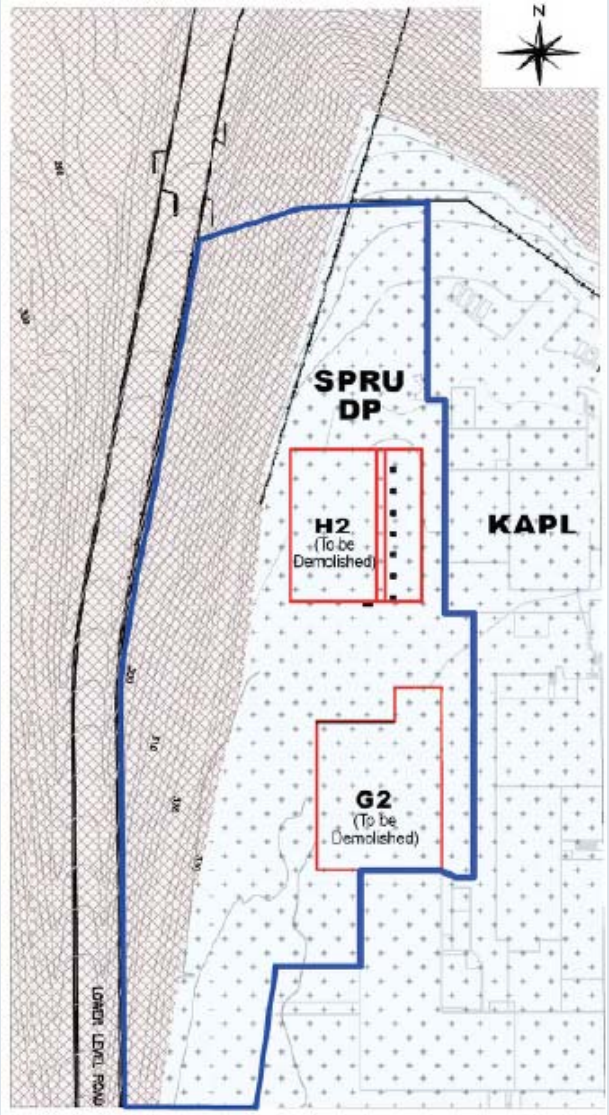
G2 and H2 Buildings Looking North, Prior to Remediation Work

Site Orientation of Buildings H2 and G2

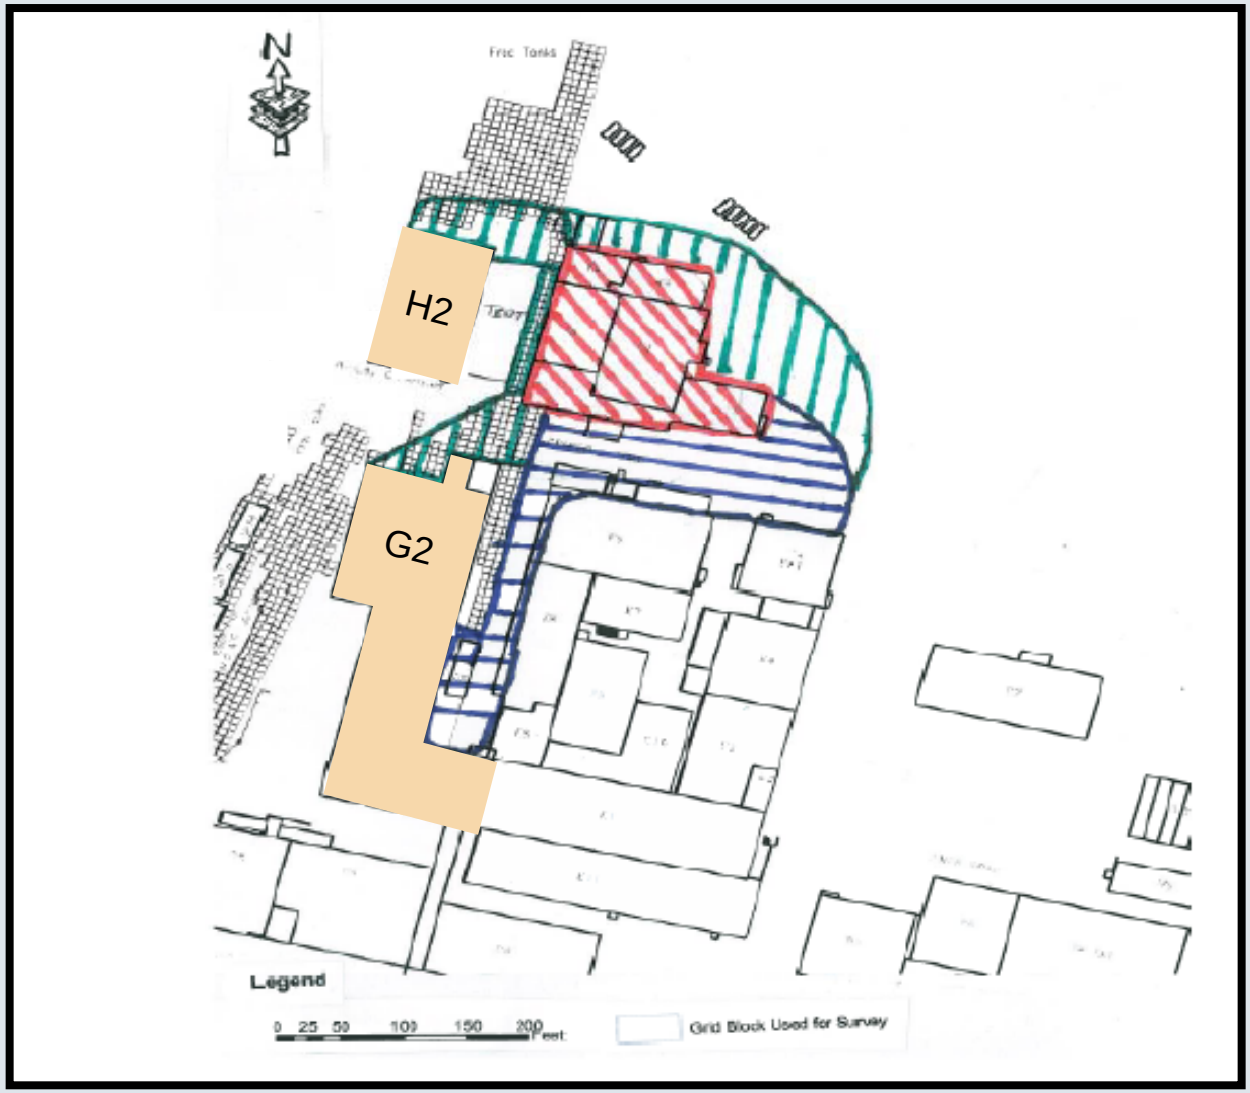
Three process system vessels were removed during demolition activities, and one vessel was size reduced contrary to work plans

- **Low level contamination was found on the shoes of four workers**
- **There was no contamination on the workers' clothing or skin**
- **Additional contamination surveys were conducted within the SPRU project footprint and over the KAPL site**
- **Radiological surveys detected contamination inside the SPRU project boundary and dispersed on the KAPL site in areas adjacent to SPRU**
- **There was no measurable deposition of contamination outside of the KAPL site boundary**
- **There was no impact to worker safety and health as a result of this event**

No Impact to Employees, Public, Environment

- **Actions to secure and stabilize work site conditions**
  - Suspended invasive work
  - Secured area and expanded radiological boundary postings
  - Performed site contamination surveys and additional air monitoring
  - Applied fixatives to suspected contamination sources debris pile
  - Bermed H2 pad to contain water
  - Placed several layers of heavy duty tarps over previously installed tarps (debris pile and evaporator tanks) for greater protection
